Crash Tests of Three Cessna 172 Aircraft at NASA Langley Research Center's Landing and Impact Research Facility

Justin D. Littell
Langley Research Center, Hampton, Virginia

NASA/TM-2015-218987

November 2015

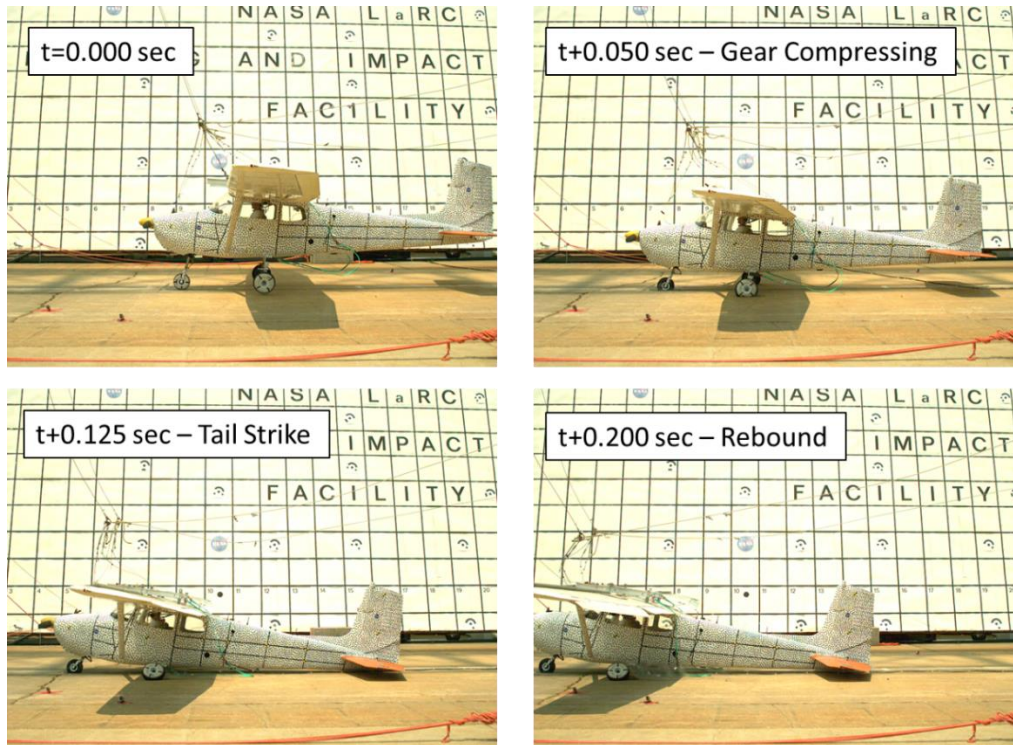
Figure 8 - Test 1 impact sequence – ground contact

In Test 1, the airplane impacted the concrete at a flight path velocity 64.4 ft/sec at an Angle of Attack (AoA) of approximately 1.5° nose high. There was approximately 0.475 sec of time between the initial impact with the ground and the first contact of the catch net. The pitch rotation and large main gear flexing caused the rear portion of the tail to strike the ground approximately 0.125 sec after impact. The primary vertical ground loading was complete at 0.200 sec, after which the aircraft rebounded with residual horizontal velocity and proceeded to impact the catch net. The propeller first contacted the net approximately 0.475 sec after initial impact. The contact continued stretching the net, until it unlatched from the uprights starting approximately 0.500 sec after initial ground impact. The net continued to wrap around the airplane until it started to move the drag weights approximately 1.120 sec after impact. All motion stopped approximately 5.85 sec after impact. Figure 8 shows the sequence of the ground contact, while Figure 9 shows the sequence of events for the net contact. Table 5 summarizes these events in tabular form.

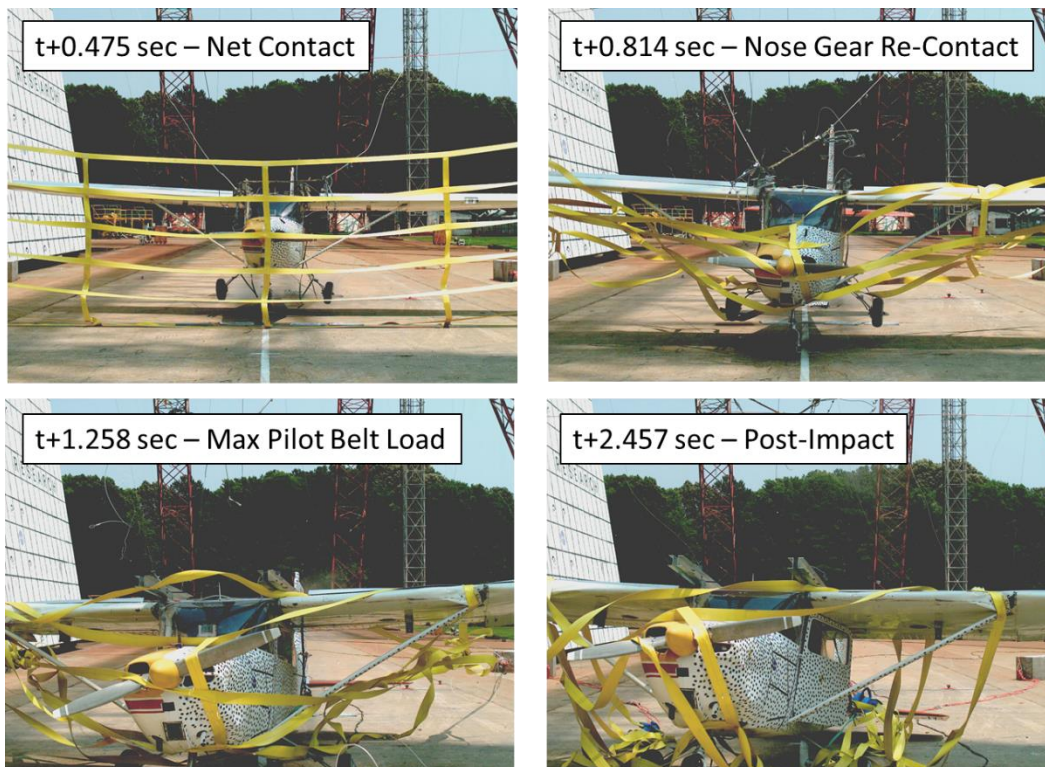
Figure 9 - Test 1 impact sequence - net contact

The second event is the airplane interacting with the catch net. The net was necessary to the test due to the constraints of the LandIR facility and not originally thought to be a part of the test. However, when investigating the results, the net can simulate a real scenario such as an airplane impacting brush, berm or other obstruction after the initial emergency/crash landing. Thus, it should be included in the data analysis in terms of its effect on the loading on the airframe and occupants. As shown in Figure 11, the horizontal acceleration in the airplane resulting from the catch net was a triangular pulse shape, lasting 0.5-sec and reaching average peak accelerations ranging between 4.0 g in the tail to 5.3 g on the engine. The large spike at the end of the net contact in the tail data is a second tail strike onto the concrete.

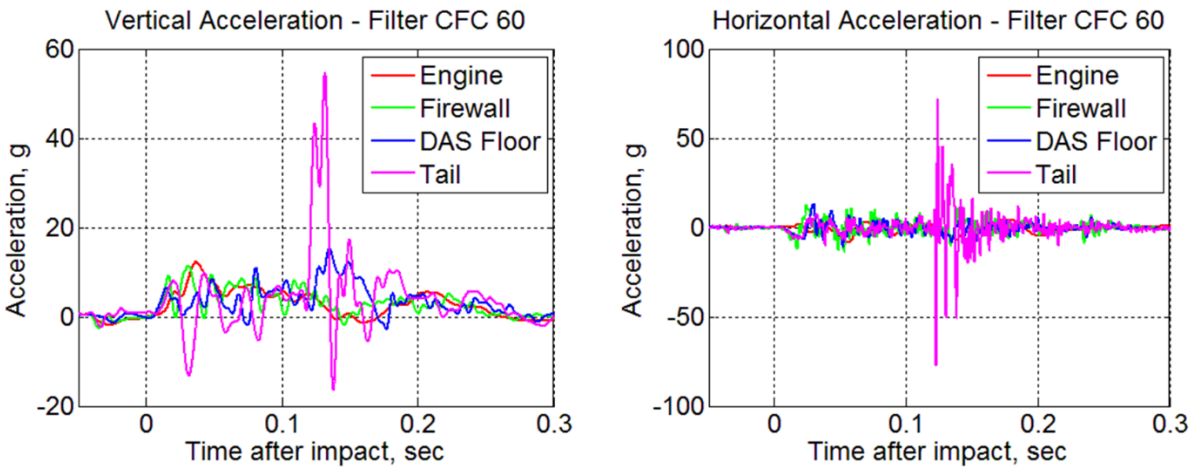
Figure 10 – Test 1 airframe accelerations during ground impact

At a high level, the test can be discussed in terms of two distinct impact events. The first event is the airplane impacting the concrete surface simulating a crash or emergency landing. In this event, which occurs for the first 0.300 sec, the landing gear deforms and the plane rebounds with minimal loss in its original horizontal velocity. As shown in Figure 10, the vertical acceleration shows a roughly trapezoidal shaped pulse resulting from the landing gear deflecting. Examining the plateau in acceleration occurring between 0.015 sec (start of plateau) and 0.200 sec (start of airplane rebound) after impact, the average sustained acceleration varies between 4.1 g in the engine to 5.9 g in the tail. The large 54.7 g peak in the tail is due to the tail strike, which occurred at 0.125 sec after the impact. The horizontal acceleration is minimal with the exception of the noise seen in the tail accelerometer, which is due to the tail strike.

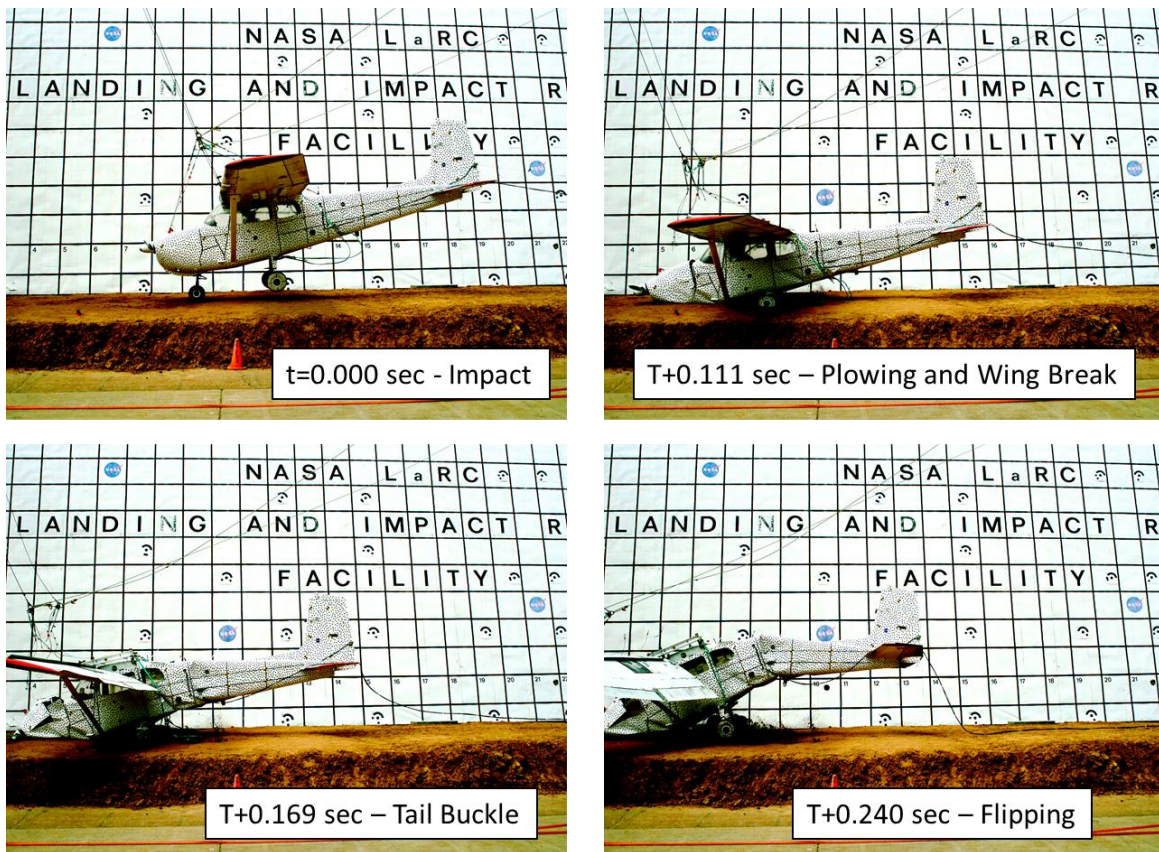
Figure 18 - Test 2 impact sequence - side view

The airplane nose gear impacted the soil first and began to plow into it. The nose of the airplane impacted the soil approximately 0.070 sec after initial nose gear contact with the soil. The nose and nose gear plowing into the soil continued to occur until the left wing broke away from the fuselage at 0.111 sec after impact. At 0.169 sec after impact, the plowing caused the tail to buckle, and at 0.240 sec after impact, the airplane

started to flip over. The flipping occurred due to the penetration of the nose gear into the soil. While the soil stopped the nose gear's motion, it also created a pivot point for the rest of the airplane to rotate around. At some point during the rotation, the nose gear broke away from the rest of the airplane. This sequence is captured in Figure 18.

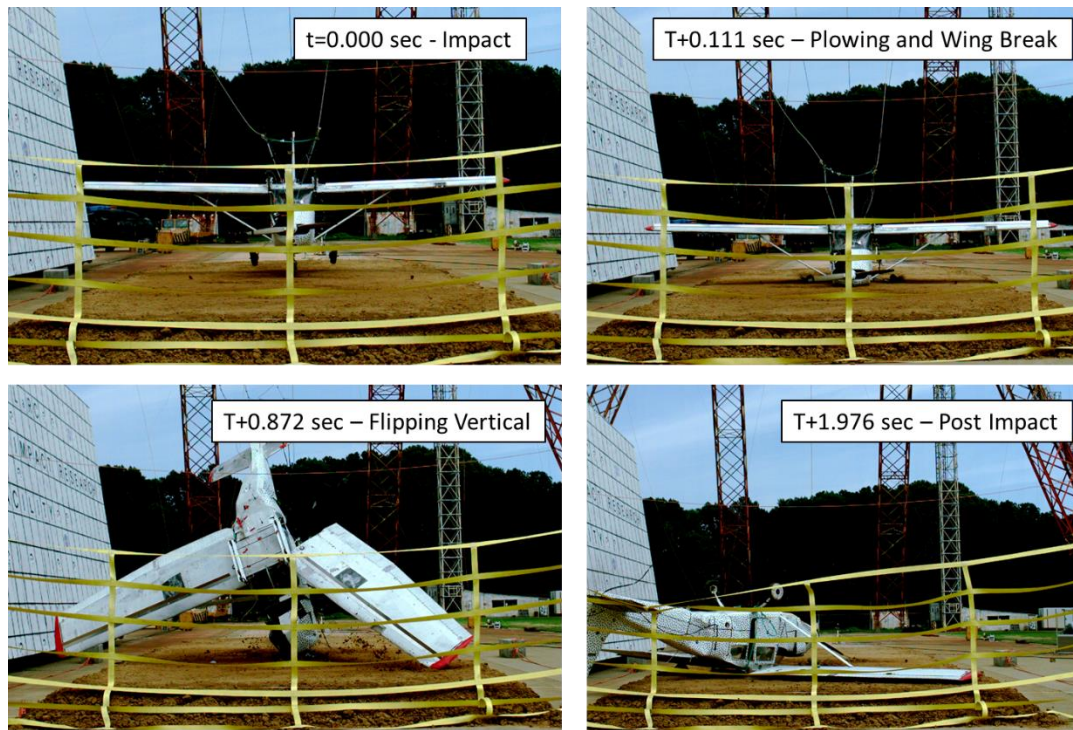
Figure 19 - Test 2 impact sequence - end view

The rest of the impact was captured from an end view camera. The rotation of the airplane continued to occur until the airplane landed upside-down approximately 1.976 sec after impact. It continued to rock back and forth until it came to final rest 6.790 sec after impact. Figure 19 shows the continuation of the impact sequence.

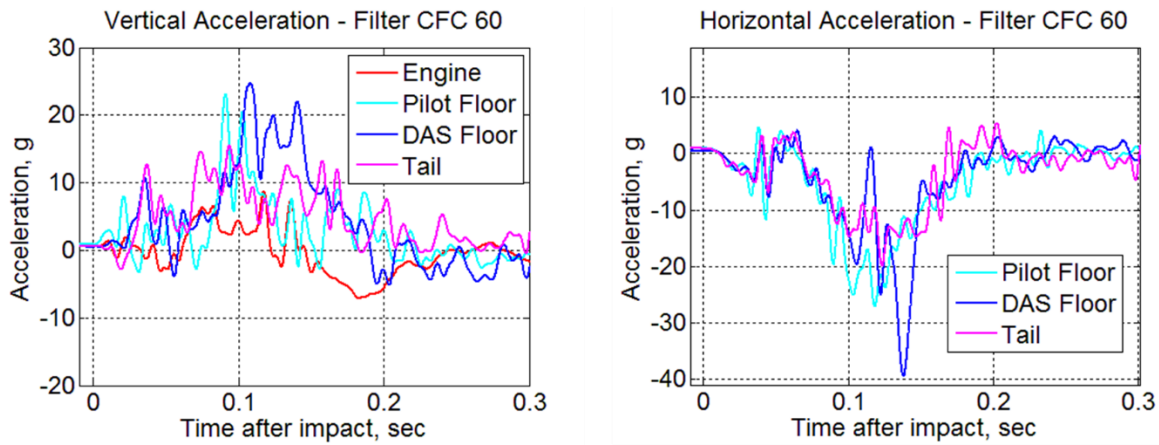
Figure 20 - Test 2 airframe accelerations

Vertical accelerations from the different portions of the airplane are different in magnitude, duration and shape, as shown in Figure 20. The engine experiences a peak acceleration of less than 9 g, which occurred 0.118 sec. after impact, after which, the engine experiences negative accelerations for the next 0.100 sec. The cabin of the airplane experiences maximum accelerations. The pilot floor accelerometer, located in the forward cabin, and the DAS floor accelerometer, located in the rear cabin, show peaks of 23.2 and 24.7 g, respectively. The tail acceleration starts negative, but then resembles a 0.130-sec plateau shape at +8.1 g mean acceleration.

Horizontal accelerations, shown in Figure 20, exhibit similar responses for both shape, magnitude and duration for all locations, with the exception of a large spike in the DAS floor. Engine acceleration is not plotted due to a severed cable which resulted in signal loss from that location, and the firewall location is also not plotted due to a small signal to noise ratio. The horizontal acceleration resembles a 0.135-sec triangular pulse with negative peaks of 27.1 g, 39.5 g and 19.9 g for the pilot floor, DAS floor and tail,

respectively. The average acceleration for the pulse shape is 18.7 g, 18.4 g and 13.5 g for the pilot floor, DAS floor and tail, respectively.

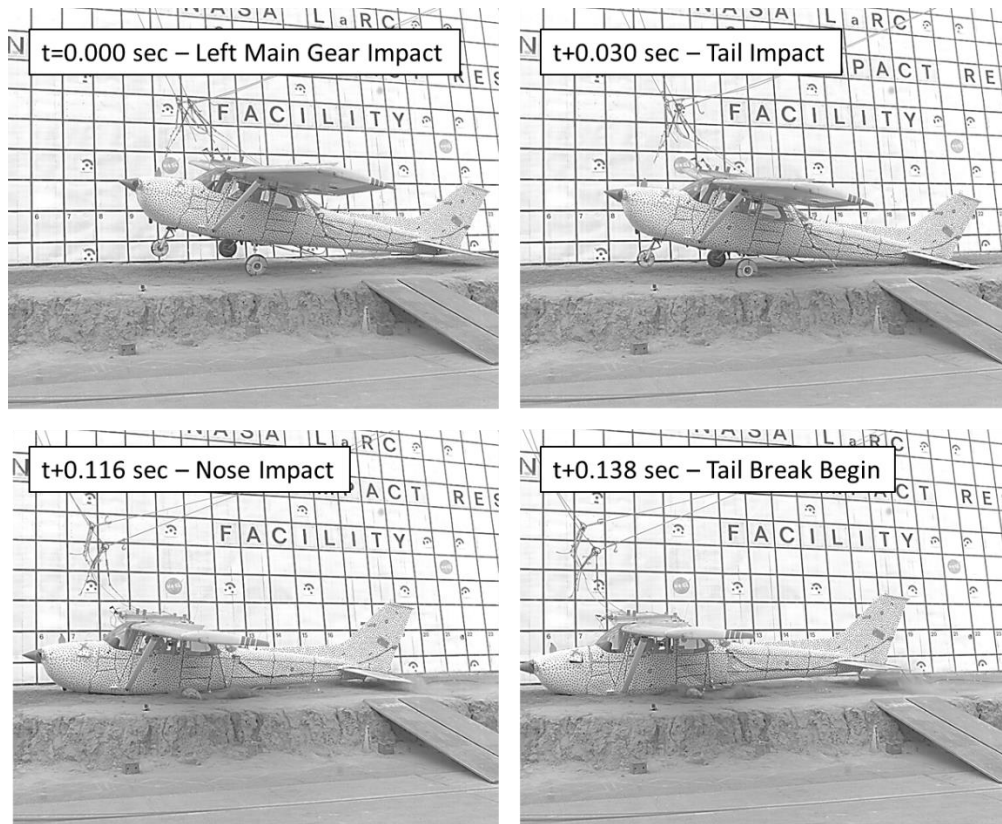
Figure 28 - Test 3 impact sequence - side view

Due to the slight amount of roll and yaw, the airplane left main gear impacted the soil first. As the tire and the gear deformed, the tail contacted the surface at 0.030 sec after impact. The nose gear, along with the nose of the airplane contacted the surface at 0.116 sec after impact. As with Test 2, it was after the nose gear penetrated into the soil surface that the airplane started to exhibit a rotation around the nose. Unlike Test 2, however, the tail developed a fracture aft of station 108 at 0.138 sec after impact. This fracture caused the tail to peel away from the fuselage, acting much like a hinge. A small portion of skin on the bottom of the aircraft retained the tail to the rest of the airplane during the rotation. The rotation of the aircraft lasted until approximately 1.53 sec after impact, at which time the ceiling of the airplane contacted the soil. The airplane rocked for a few seconds before finally coming to rest at almost 5 sec after initial impact. A time sequence is depicted in Figure 28, as captured from one of the black and white side view cameras and Figure 29, as captured by the end view camera.

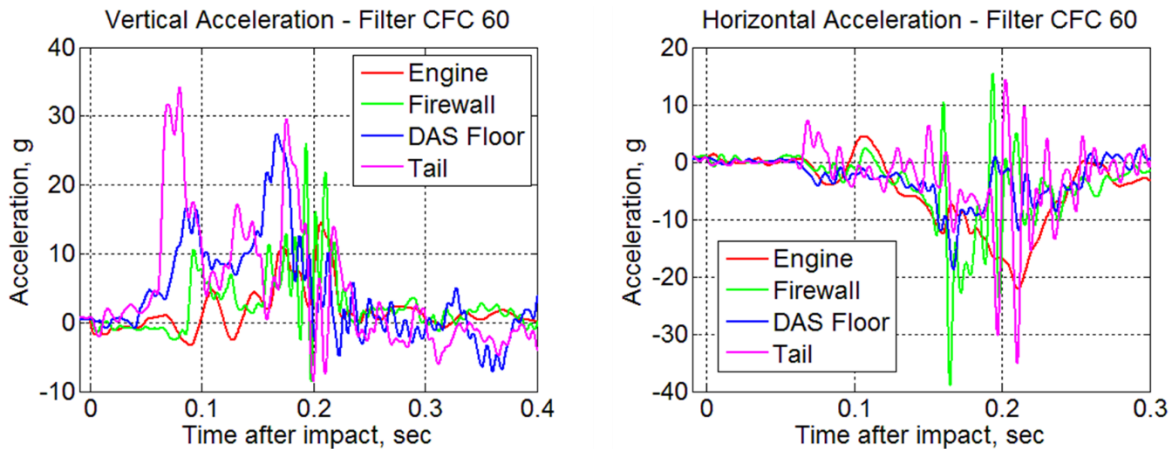
Figure 30 - Test 3 airframe accelerations

Figure 30 shows the airframe accelerations. A slap down effect can be seen in the vertical acceleration plots. The tail strike is first captured by the instrumentation approximately 0.080 sec after initial impact and reaches a peak of approximately 32 g. The peak accelerations from locations going from aft to forward then occur in sequence. These accelerations reach their peaks of 27.5 g, 26.0 g, and 15.5 g, at 0.165 sec, 0.193 sec and 0.206 sec after first contact for the DAS floor, firewall and engine, respectively. The vertical acceleration pulse duration for all locations is approximately 0.240 sec.

The horizontal accelerations resemble either a triangular or trapezoidal pulse shape, depending on the location under investigation. The engine acceleration peaks at -22.1 g at 0.210 sec after impact, shaped over a 0.180-sec triangular pulse. The firewall, exhibited a peak acceleration of -38.9 g; however, this peak is likely due to the increased noise in the signal from the firewall location. The peak occurs at 0.165 sec after impact and the shape also resembles a 0.180-sec triangular pulse. The DAS floor and tail are more representative of a trapezoidal pulse, having a 0.050-sec sustained acceleration and a total pulse width of 0.250 sec. The DAS floor sustained peak acceleration is approximately -8.7 g, while the tail reaches a sustained peak acceleration of -8.1 g. The accelerations are caused from the dragging of the airplane through the dirt before rotation around the nose gear tire begins, and they occur mainly in the rear portions of the airplane due to the tail strike condition.
